## WAIMAKARIRI DISTRICT COUNCIL

### REPORT

**SUBJECT:** Kaiapoi Riverbanks Projects : Bridge to Wharf Connection and Wharf Development

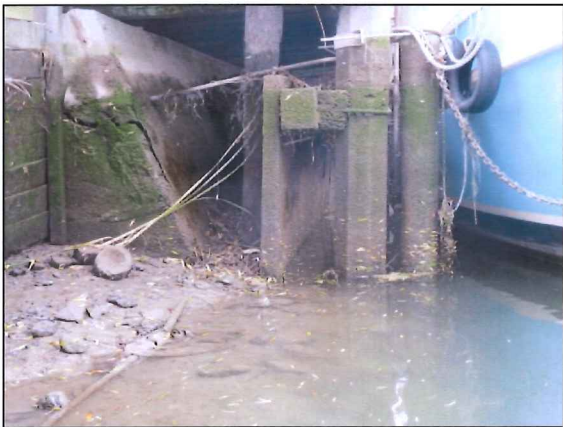
- A settlement crack was observed in the concrete retaining wall, refer photo 4, Appendix 1.
- The upstream edge of the retaining wall has cracked and spalled as observed in photos 1 and 2, Appendix 1. The concrete surrounding the tieback rod appears sound. The damage to the end of the retaining wall is unlikely to initiate global collapse of the wharf.

<b>Upstream Wharf (photos taken 2013/2015)</b>		
<b>No.</b>	<b>Item Description</b>	<b>Photo</b>
<b>1.</b>	General view of the damaged retaining wall at the upstream end of the wharf.

Recommendation – *Monitor condition of the cracks. Should the cracks deteriorate in the future, repair is likely to be required.*

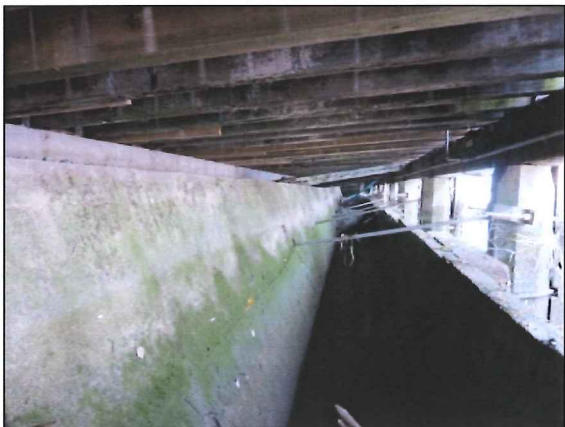
A close-up photograph of the damaged retaining wall, showing a large crack and exposed rebar. The wall is covered in green algae or moss.
<b>3.</b>	General view along the retaining wall.

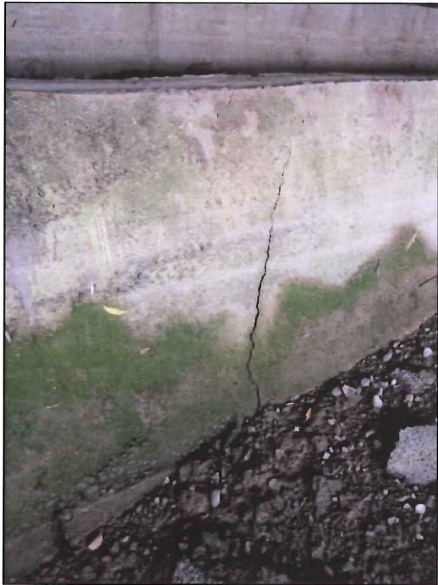
4.	Detailed view of the settlement induced crack in the retaining wall.

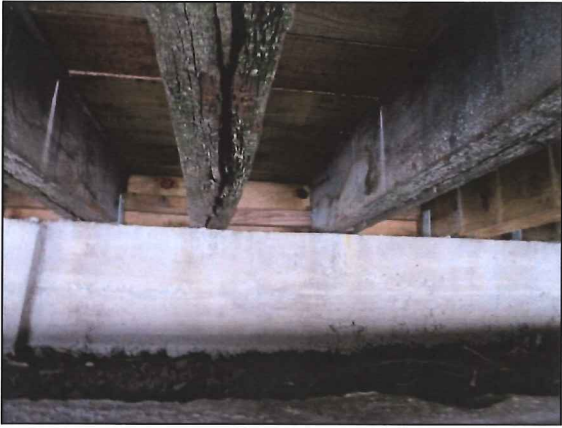
- i) Although outside of the scope of this report, a number of timber stringers were noted to have significant decay and may require replacement in the near future.

5.	Deterioration of a typical hardwood stringer (sitting on the concrete sill beam).

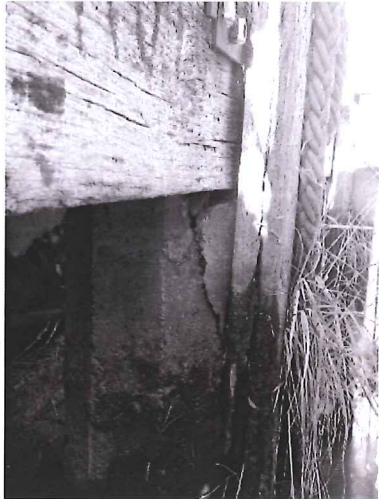
- Most of the concrete piles have spalled around the connection of the piles to the hardwood capping beam refer to photos 6 and 7 Appendix 1. This damage was also documented 20 years ago in the 1995 Works Consultancy Services condition report, a photo from this old report is included as photo 9 in Appendix 1 of this report.
- The spalling of the concrete piles does not appear to have deteriorated significantly in the last 20 years including the Canterbury Earthquake sequence.
- In addition to the spalled concrete, the steel plate connections have surface rust. We are unsure of the depth of the steel plates into the concrete piles and therefore we have some concern that the spalling may have significantly reduced the pull-out and shear capacity of the original pile/cap beam connection.

6.	Spalling of concrete pile (10 May 2015).

*Recommendation – Whilst the deterioration of the connection between the concrete piles and the hardwood capping does not appear to have deteriorated significantly in the last 20 years, this is a critical connection for the integrity of this structure in a future seismic event and therefore we recommend that the spalling is repaired and a new connection between the pile and capping beam is provided.*

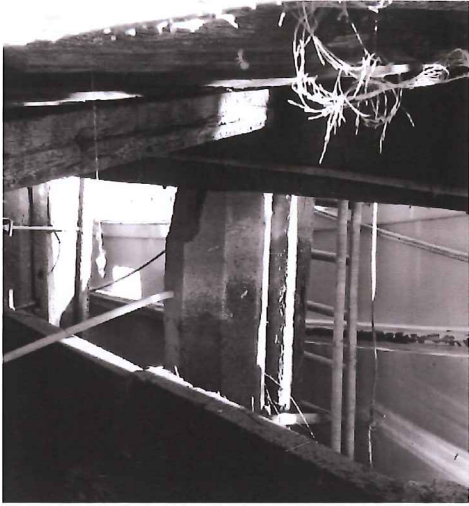
7.	Spalling of concrete pile (10 May 2015).

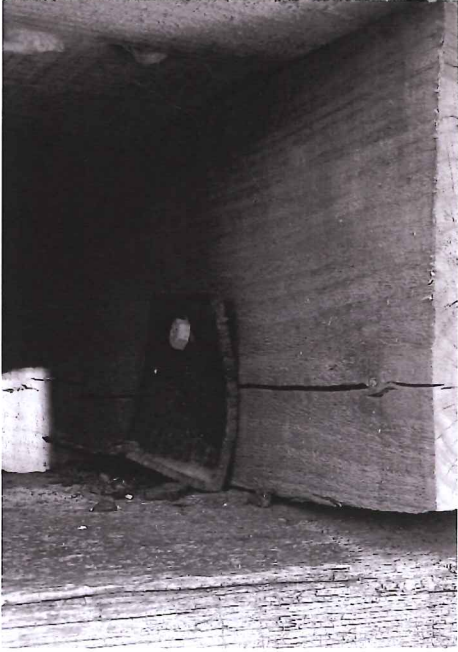
- The connection between the capping beam and the stringers consists of a steel angle. The angle has surface rust but appears to be sound. A few of the angles were observed to be bent, refer to photo 8, Appendix 1.

8.	Damaged connection between hardwood capping beam and a stringer

*Recommendation – As this is also a critical connection for the integrity of this structure in a future seismic event we recommend that all existing coach screws are replaced with new through bolts and large washer plates and, where the angles are deformed, that the angle brackets are replaced.*

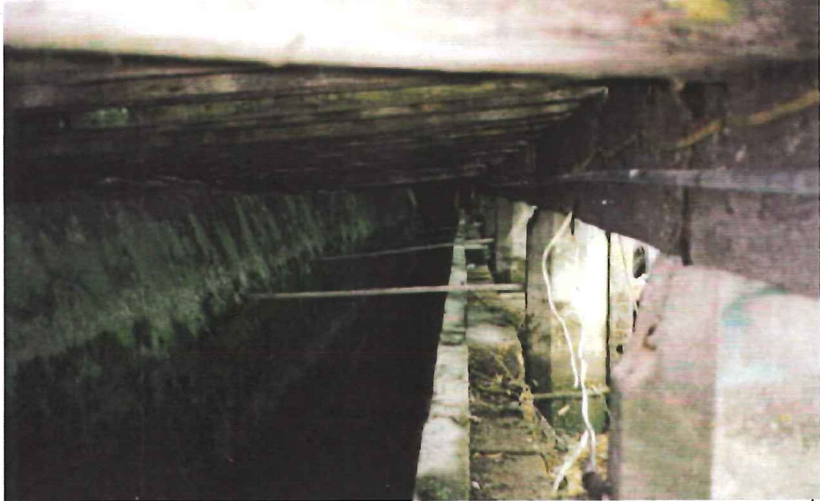
Upstream Wharf (photos taken 1995)		
No.	Item Description	Photo
9.	Spalling of concrete piles (21 February 1995).

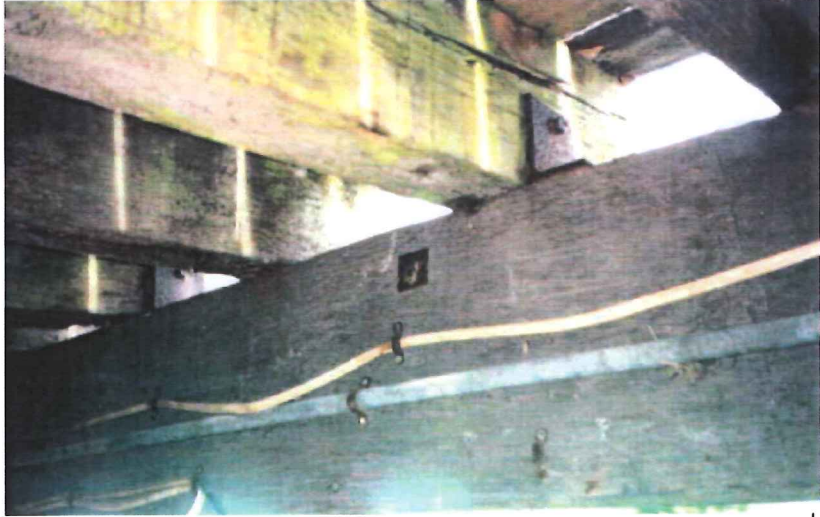
10.	Surface rust of connection between hardwood cap beam and timber stringers (21 February 1995).
